ILLINOIS ENVIRONMENTAL PROTECTION AGENCY

MEMORANDUM

SUBJECT: South Central Terminal / Edwards Farm Supply May 3, 1999, Site Visit;
Pana (Christian County) IEPA/USEPA Joint Inspection

South Central Terminal / Edwards Farm Supply

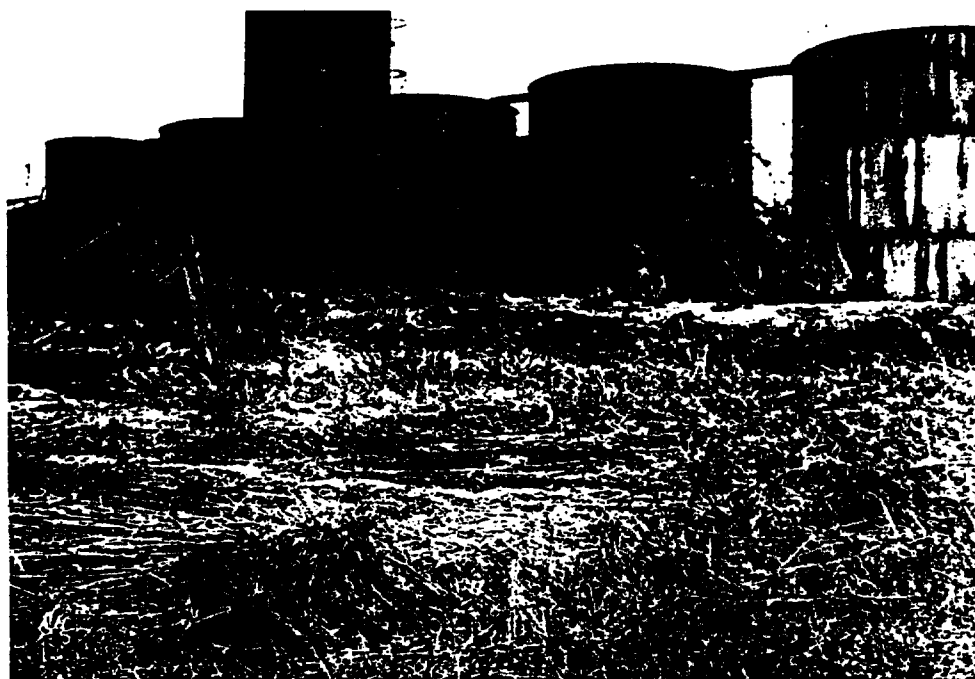
Photograph Taken by: TDZ Photo # 3

Location of Area Photographed: area west of old asphalt plant - facing
NE towards asphalt plant tanks, evidence of recent earthwork
